ST. JOE STATE PARK DAM  
ST. FRANCOIS COUNTY, MISSOURI  
MO 30277

# PHASE 1 INSPECTION REPORT NATIONAL DAM SAFETY PROGRAM

FEBRUARY 1980

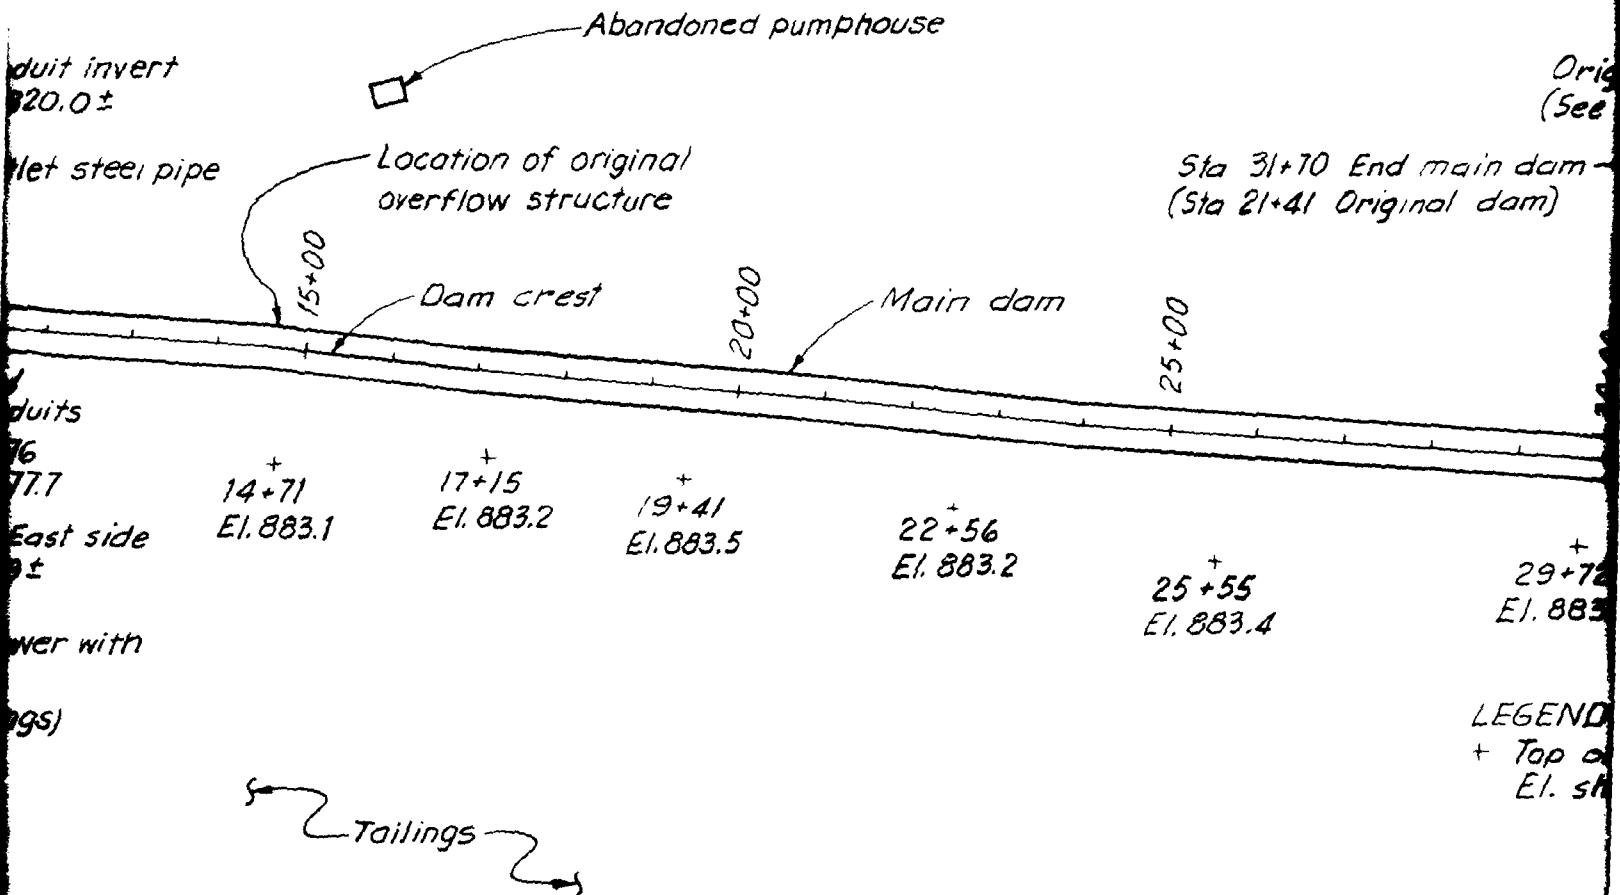
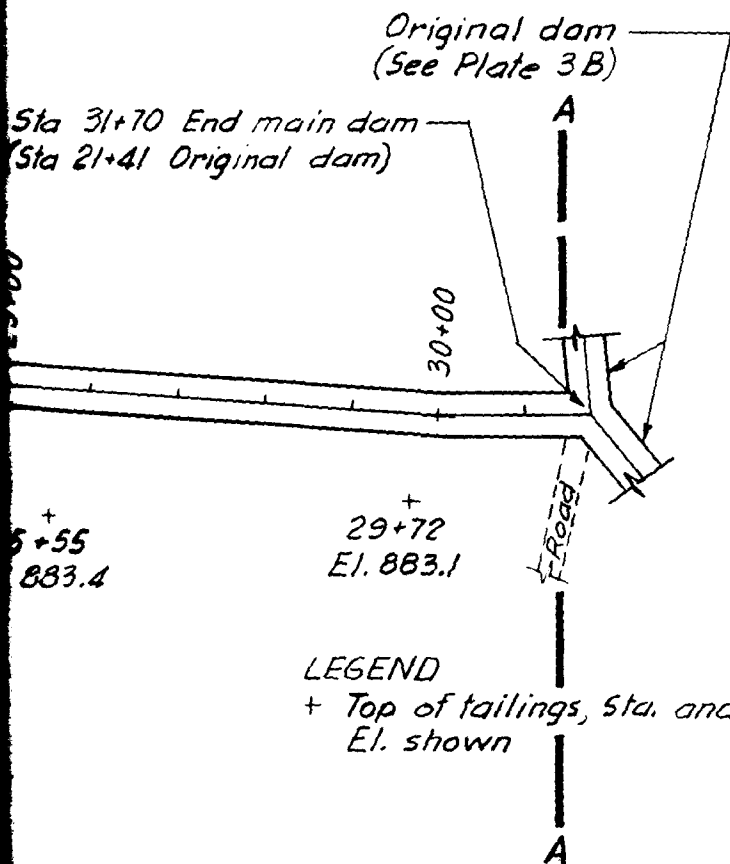
PLATE 3A

c. Dam. The plan of the main dam is shown on Plate 3A, and the plan of the original dam is shown on Plate 3B. The profile and cross sections of the main and original dams are shown on Plates 4 and 5. The profile of spillway A at the left abutment of the main dam is shown on Plate 6, and a road profile along the left abutment hillside upstream of the main dam which includes cross sections of spillways A and B is shown on Plate 7A. A cross section of spillway C is shown on Plate 7B. Plate 8 shows pertinent dimensions and elevations of the main dam intake tower as determined from field measurements on 25 August 1979.

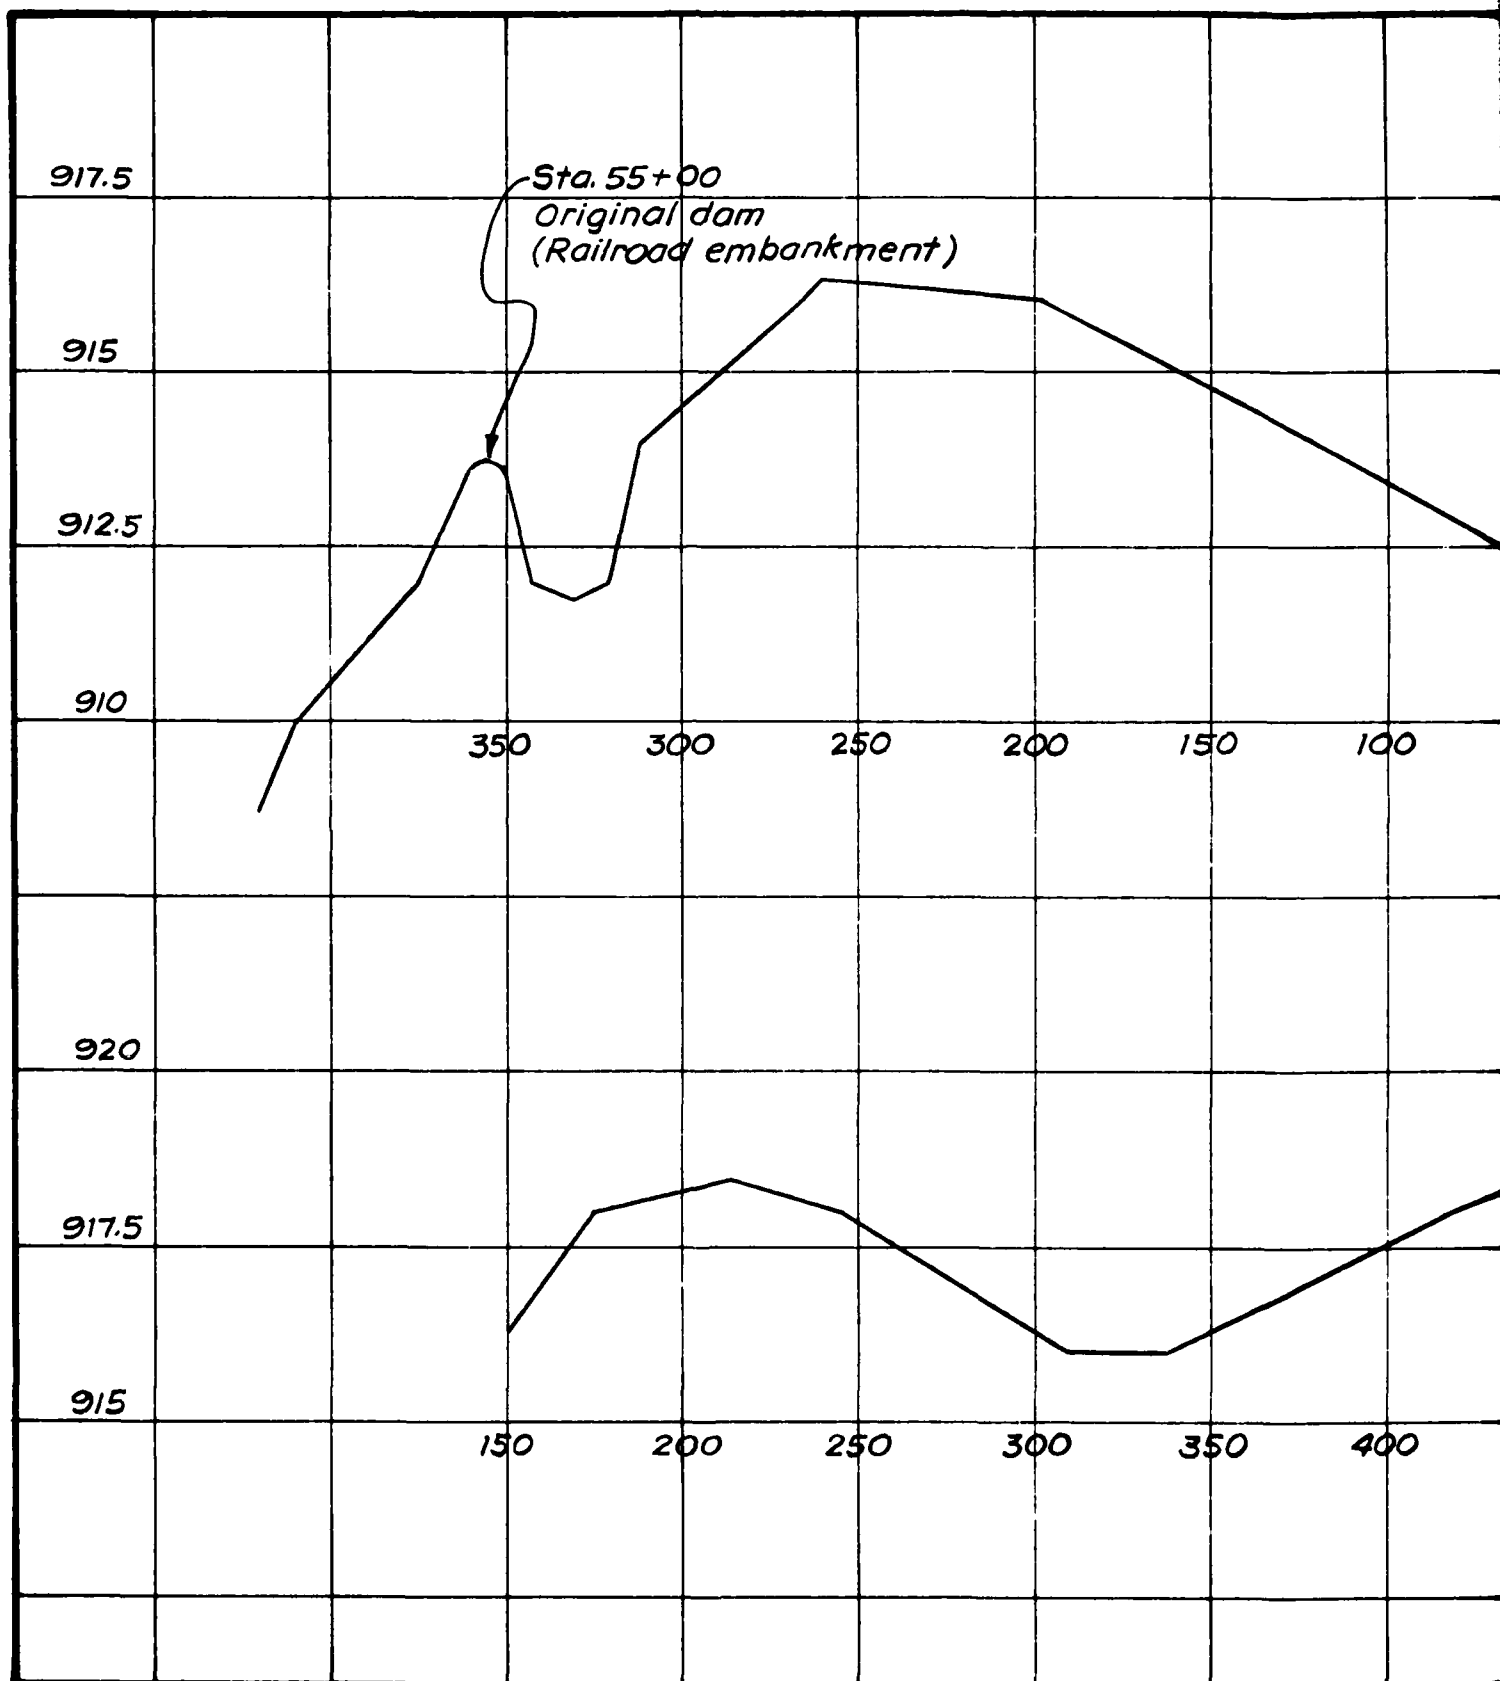
PLATE 7B

A low point in the natural terrain, approximately 350 feet east of the railroad embankment, at original dam Station 54+00, would allow a discharge to flow from subarea 2 into the neighboring drainage north of the dam. This low point has been designated spillway C. A cross section of spillway C is shown on plate 7B.
